CAPITAL PLAN

FORT VERMILION SCHOOL DIVISION

**FORT VERMILION SCHOOL DIVISION
THREE YEAR CAPITAL PLAN
2025 – 2028**

FORT VERMILION SCHOOL DIVISION
SANDHILLS ELEMENTARY SCHOOL
10202 94 Ave, La Crête, AB T0H 2H0

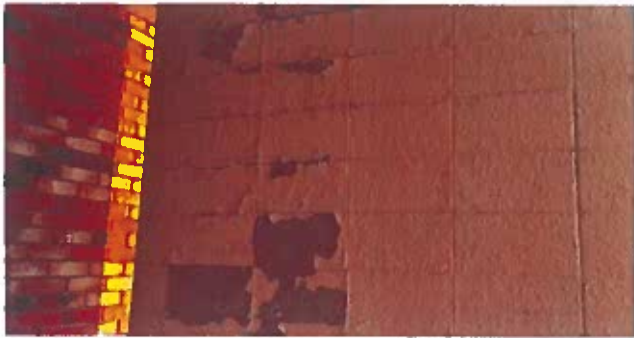
Spalling was noted on the exterior concrete block texture.

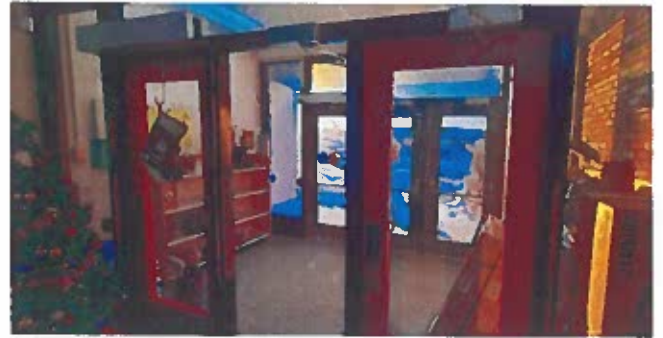
The main entrance of the school suffers from a lack of crush space that causes congestion for students, parents, and visitors.

There is a lack of crush space at the main entrance which causes congestion for students and parents.

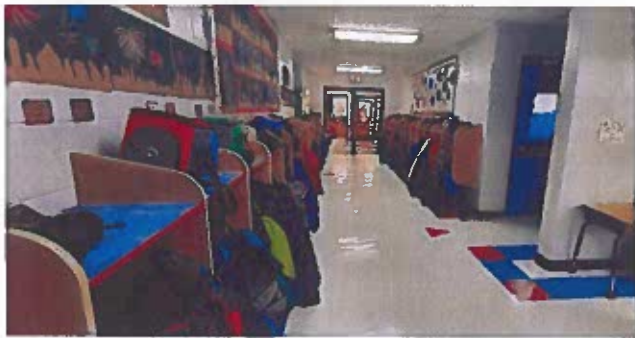
There is a lack of corridor space for cubbies and hooks.

Additional coat and hook space is needed throughout the school.

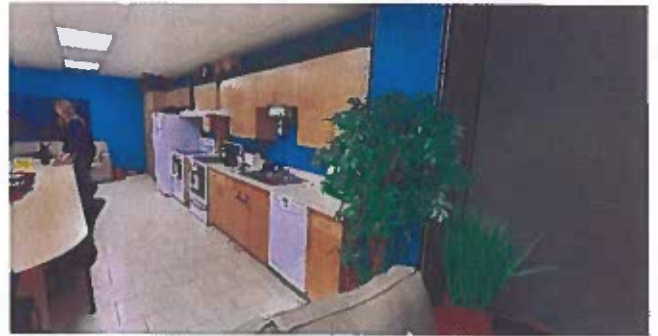
The staff room is undersized for the number of staff and is also used by parents as a kitchen space for preparing hot lunches.

A separate server area is required so that parents are not required to

use the staff room to prepare lunches.

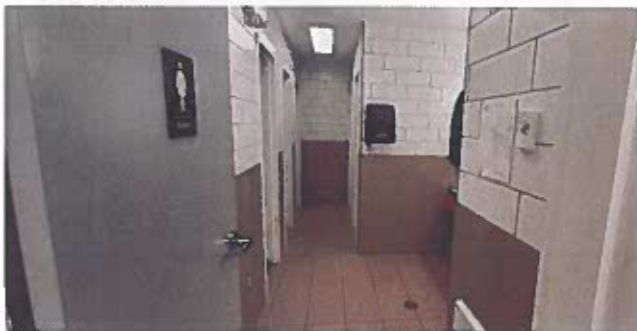
Staff washrooms have been expanded.

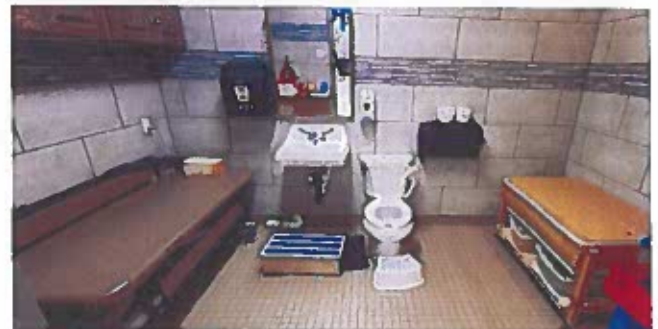
Due to the high number of students with complex needs, the universal washroom is fully scheduled.

The school has a high number of students with complex needs and the universal washroom requires a fully booked schedule with little flexibility.

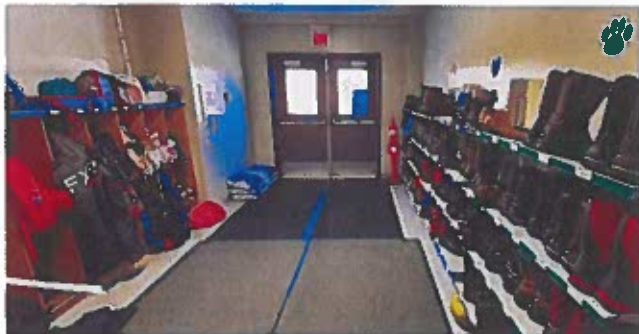
All vestibules are experiencing congestion.

3. **Circulation:** Vestibules are congested, specifically the link entrance for the modular classrooms.

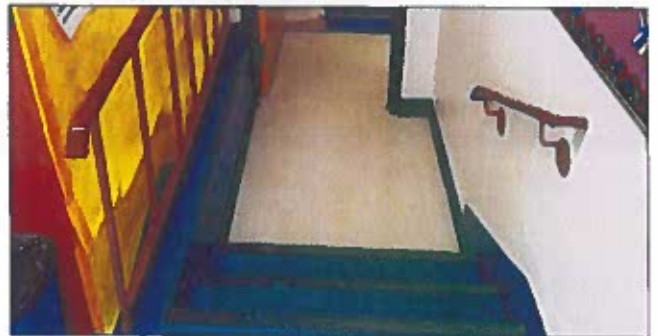
Accessibility to classroom 105 is an issue due to the space being the former stage.

Room 105 has a raised floor and stair access with no barrier-free accessibility.

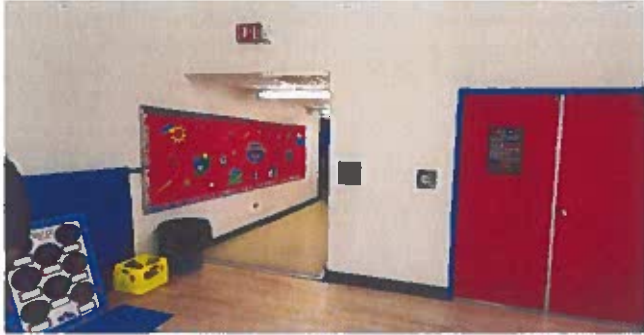
The single access point into the gymnasium causes congestion for students and community use.

- 6. Community Use:** It was noted that the lack of change rooms can be an issue for community use. The school also lacks adequate secure lock-off points to control community access to school spaces during after-hours use. Additionally, with only one access point into the gym, congestion is an issue.

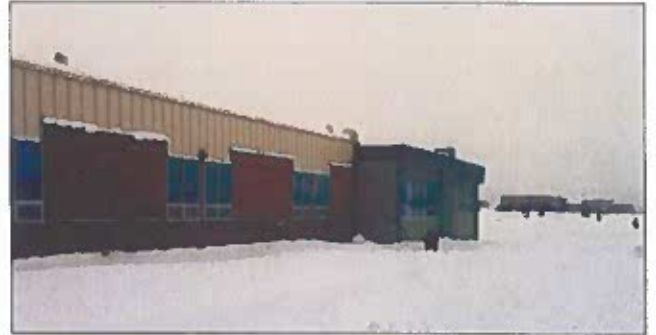
Supervision and lighting level is an issue on the North side of the modular classrooms.

- 2. Site Supervision:** Site supervision is an issue along the North side of the modular classrooms. Lighting also needs to be improved on both sides of the North modulares and at the staff parking area.

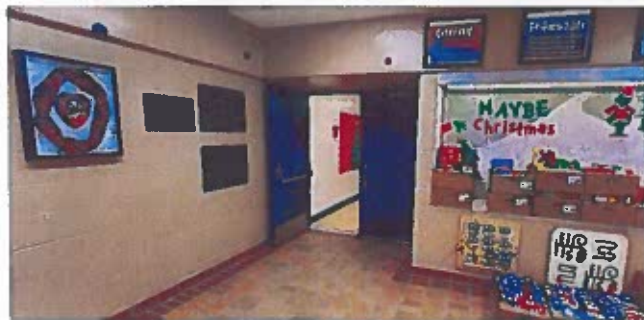
The single access point into the gymnasium causes congestion for students and community use.

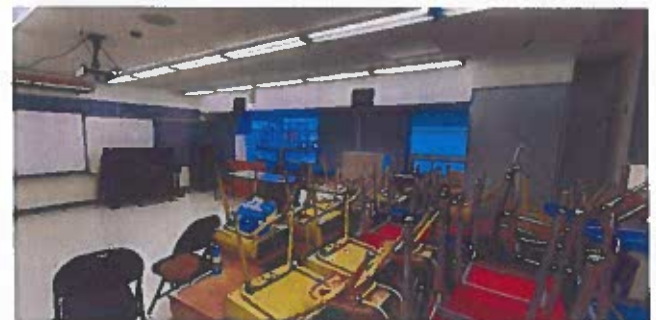
With a reduction in utilization, a number of classrooms are being used for sensory / pull out / meeting space / storage.

- 3. Building Circulation:** It was noted that due to the configuration of the portable classrooms, the building is very spread out and the long distances impact instructional time. Due to low utilization, a number of classroom spaces are being used for sensory / pull out / and meeting space. The core of the school can be reconfigured into more effective collaboration space and unused portable classrooms can be removed to address travel distances and increase utilization.

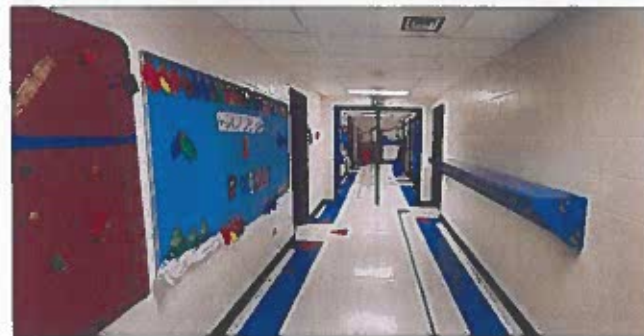
Previously, the lack of pull out spaces required that desks and teaching locations were in offices, the library, staff room, and corridors. With a reduced utilization, these activities take place in classrooms but with an increase in enrolment, this issue will reoccur.

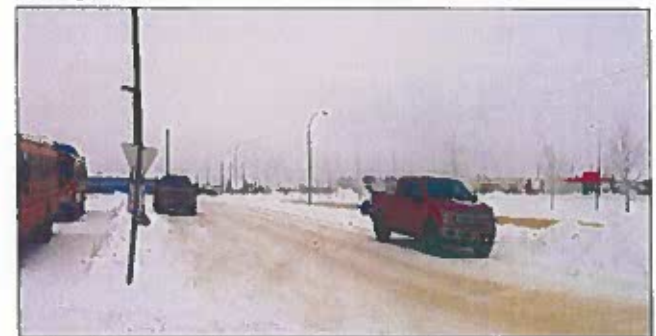
With the construction of the bus loop area to the North of the school, site congestion has been improved but a clear and dedicated drop-off is required to address parent traffic.

- 1. Site Circulation:** With the construction of the bus loop area to the North of the school, site congestion has been improved but a clear and dedicated drop-off is required to address parent traffic.

- 1. Site Circulation:** A clear and dedicated student drop off lane is required to address parent traffic issues.
- 2. Informal / Small Group Learning Spaces:** The central core of the school can be reconfigured to provide additional collaboration spaces. Two pull out spaces have been provided in the library but additional space is required. This would be accomplished by reconfiguring the existing Kindergarten, Classroom 138, and Library and creating an interconnected learning commons with associated break out spaces, small counselling areas, and alcoves where small group learning could take place.

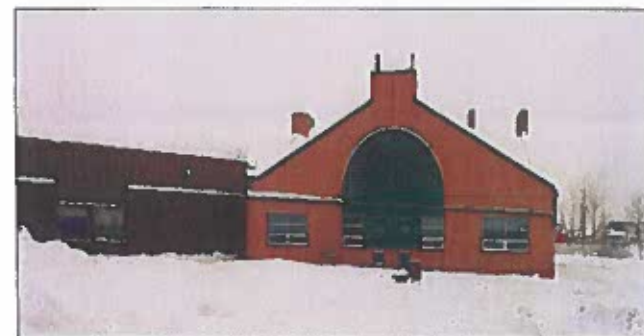
Pooling occurs on the site at the South modulares during spring thaw. Lighting levels should also be improved in this area.

- 3. Site Drainage:** There is pooling at the North and South modulares with ice at many of the entrances.
- 4. Informal / Small Group Learning Spaces:** There is a deficiency of dedicated break out and counselling spaces for smaller group work. Due to a lower utilization, classrooms are being used for pull out space.

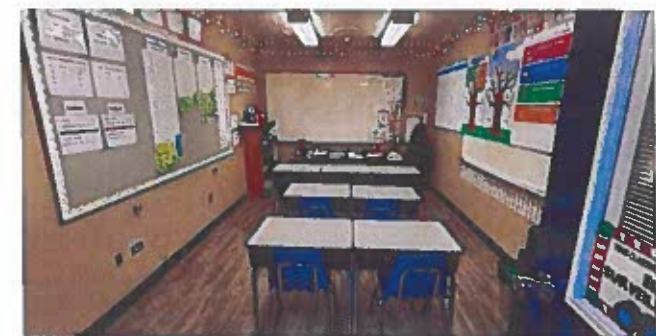
The school has a large central core of instructional spaces with no natural lighting or ventilation.

- 11. Natural Light / Ventilation:** The planning of the school has a large central core of instructional spaces and the lack of natural light in these areas was noted. It was also noted that the classrooms along the South side of the school have small windows that have failed and are dirty between the glass panes.

- 6. Natural Lighting:** The existing windows in the South classrooms could be replaced and enlarged to introduce additional natural light and ventilation.
